# SITUATION

## **LOCTITE SOLUTION**

## LOCTITE 638

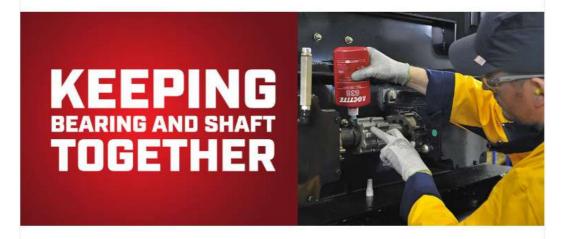
A cement manufacturer was faced with repeated cases of bearing loosening on shaft due to high temperature and torque load. This led to costly repairs, hardfacing the shaft which was costly and led to 5 hours of production downtime everytime the bearing spun.

Shrink fit produces fit on the principle of friction. However there's only 20-30% metal to metal contact and the rest is gap. This gap allows dynamic loads to loosen the bearing.

Loctite 638 was applied by maintenance personnel, which filled all the gaps between the bearing and the shaft unitizing the assembly against dynamic rotational loads.
