RETAINING BEARING ON A WORN SHAFT

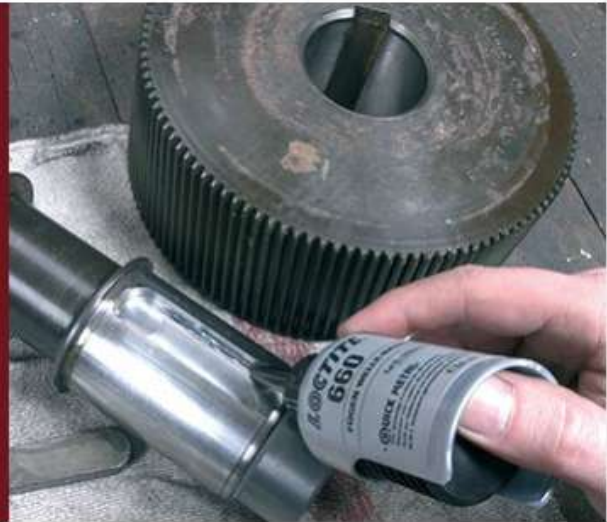
A cement manufacturer was facing a problem with the wearing of a large diameter shaft that could no longer retain its main bearing. Waiting for a new shaft to be made and delivered would be a large production loss for the company. Welding the bearing on shaft was out of question as it would damage the shaft's structure. A solution was needed which would reliably fit the bearing on the worn shaft before the scheduled maintenance takes place.

LOCTITE 660 was used to fit the bearing on worn shaft as it can fill up to 0.5mm of clearance. Once applied it filled the entire space hardening into a tough thermoset plastic that unitized the bearing to the shaft. The roller mill was back in service in no time at the lowest repair cost
