! SITUATION

A steel company was facing repeated cases of leakages from the gearbox flanges. High vibrations and heavy shock loads experienced by the gearboxes loosened the bolts which mount the housing. This reduced the clamp load on the gaskets which led to costly leaks and necessitated immediate cleanup to prevent accidents and gear seizure.

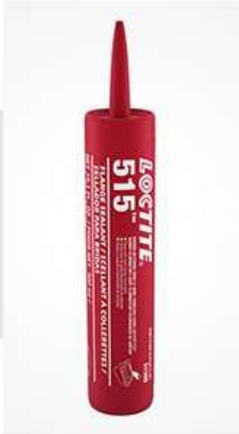
LOCTITE 515
Pre-cut gaskets are held in place by the mounting bolts. Once the bolts loosen the cut gaskets cannot maintain seal and gaps appear leading to leaks.

RESULTS

Low inventory of cut gaskets

Reduced downtime due to fast repair time

Elimination of costly oil leakage
