THREADLOCKING MOUNTING BOLTS AGAINST LOOSENING

LOCTITE 277

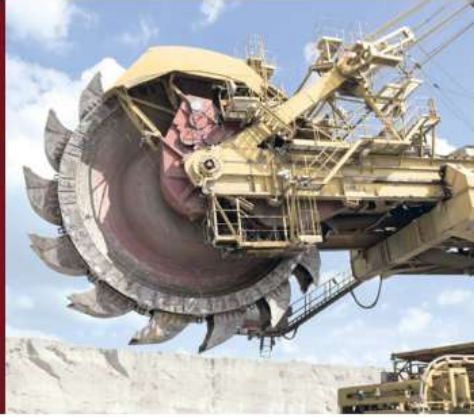
A mining operation was facing repeated loosening and breaking of jaw crusher mounting bolt due to heavy vibrations. The bolt, post loosening, got sheared. This caused the crusher frame to pound against the concrete footing, damaging both the frame and the footing. Additionally, the potential collapse of jaw crusher presented a severe safety issue.

Split spring washers do not solve the root cause of vibrational loosening which is the gap between the nut and the bolt. This gap allows side to side movement when the crusher is subjected to shock and vibrations.

LOCTITE 277 Threadlocker was used to fix the issue. The product addressed the root cause of the loosening which is the gap by filling it completely and solidifying into a hard thermoset plastic that strengthens the anchor bolts.
