SMOOTH TRANSMISSION SECURED

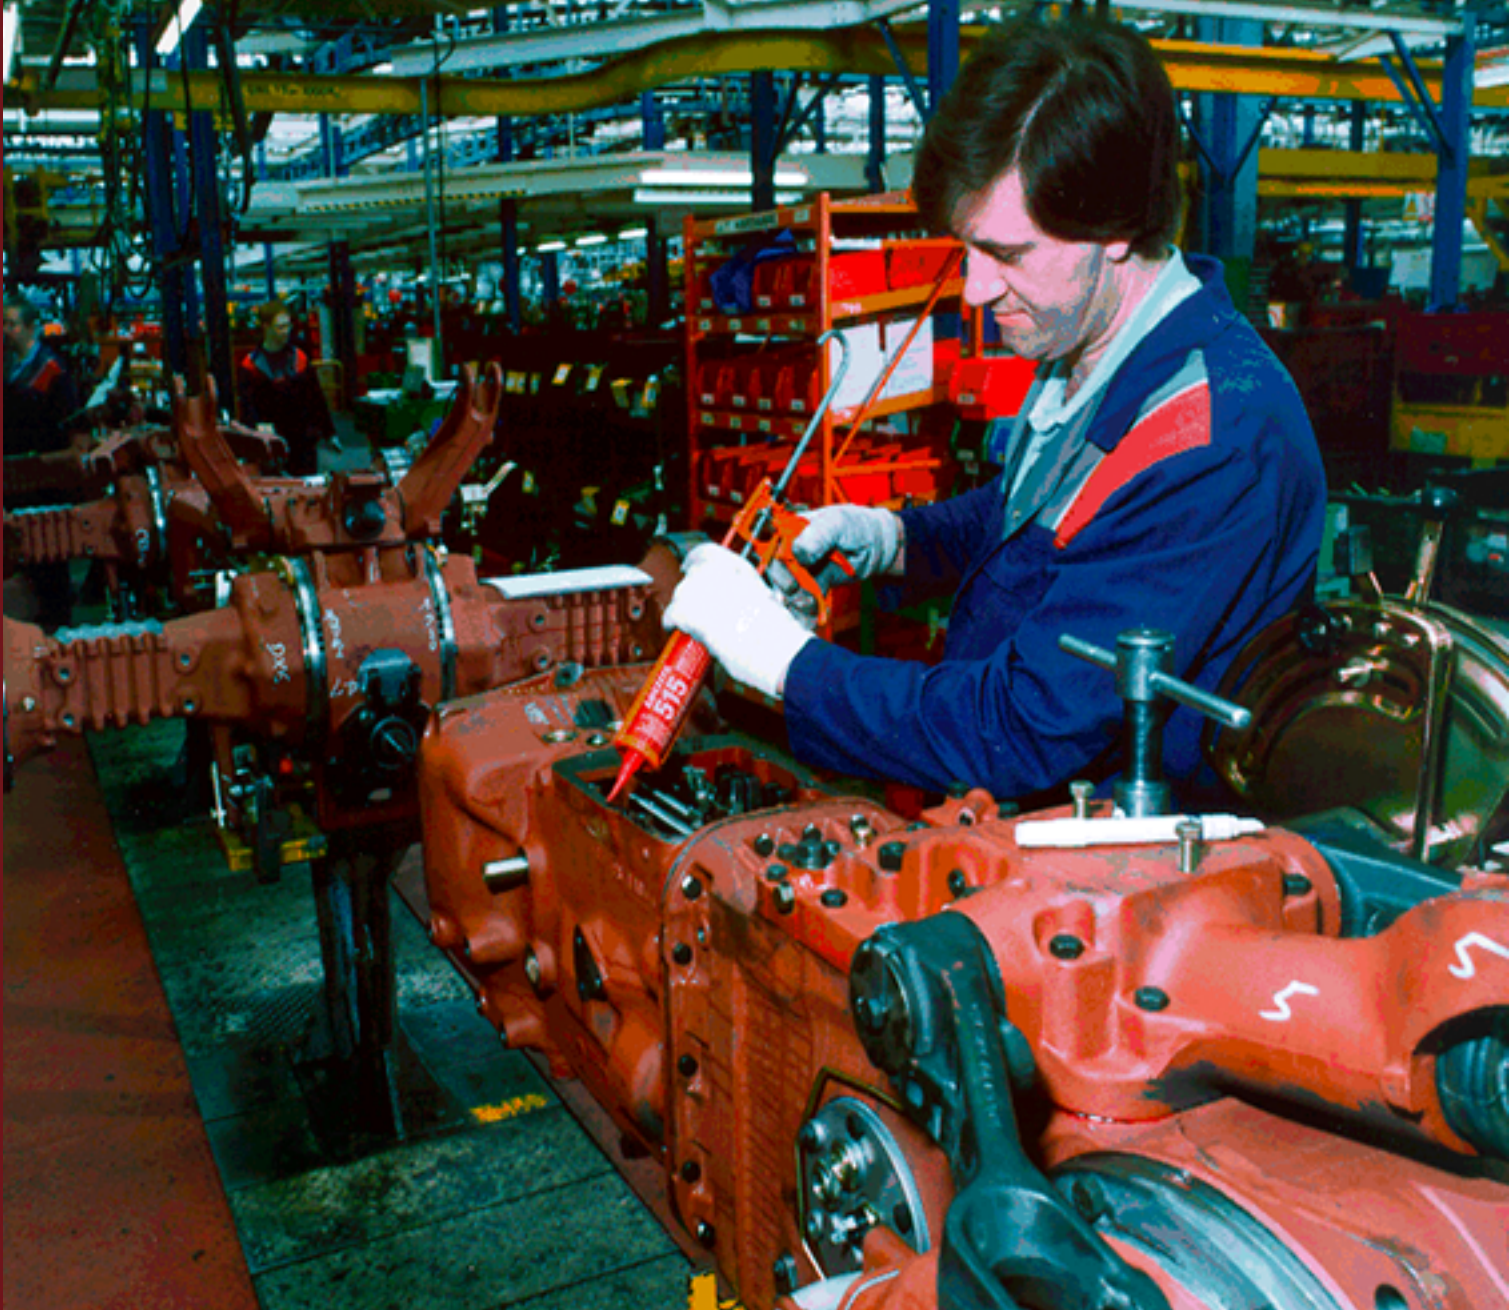
A steel company was facing repeated cases of leakages from the gearbox flanges. High vibrations and heavy shock loads experienced by the gearboxes loosened the bolts which mount the housing. This reduced the clamp load on the gaskets which led to costly leaks and necessitated immediate cleanup to prevent accidents and gear seizure.

Pre-cut gaskets are held in place by the mounting bolts. Once the bolts loosen the cut gaskets cannot maintain seal and gaps appear leading to leaks.

LOCTITE 515 flange sealant was used to seal gearbox flanges. Being liquid it occupied all surface irregularities and hardened to form a hard thermoset plastic which unitized the assembly against leakages.
