# MAINTAINING AFOOD SAFE PLANT

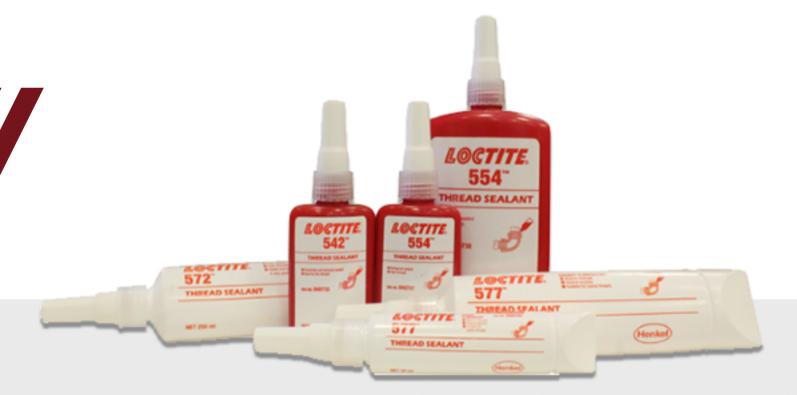
**LOCTITE thread sealants** comply with international food processing quality inspections. They do not shred or contaminate the fluid media. Additionally they prevent stainless steel fitting leaks from vibration loosening, shock loads, or galling.
